Crash Tests of Three Cessna 172 Aircraft at NASA Langley Research Center's Landing and Impact Research Facility

Justin D. Littell
Langley Research Center, Hampton, Virginia

NASA/TM-2015-218987

November 2015

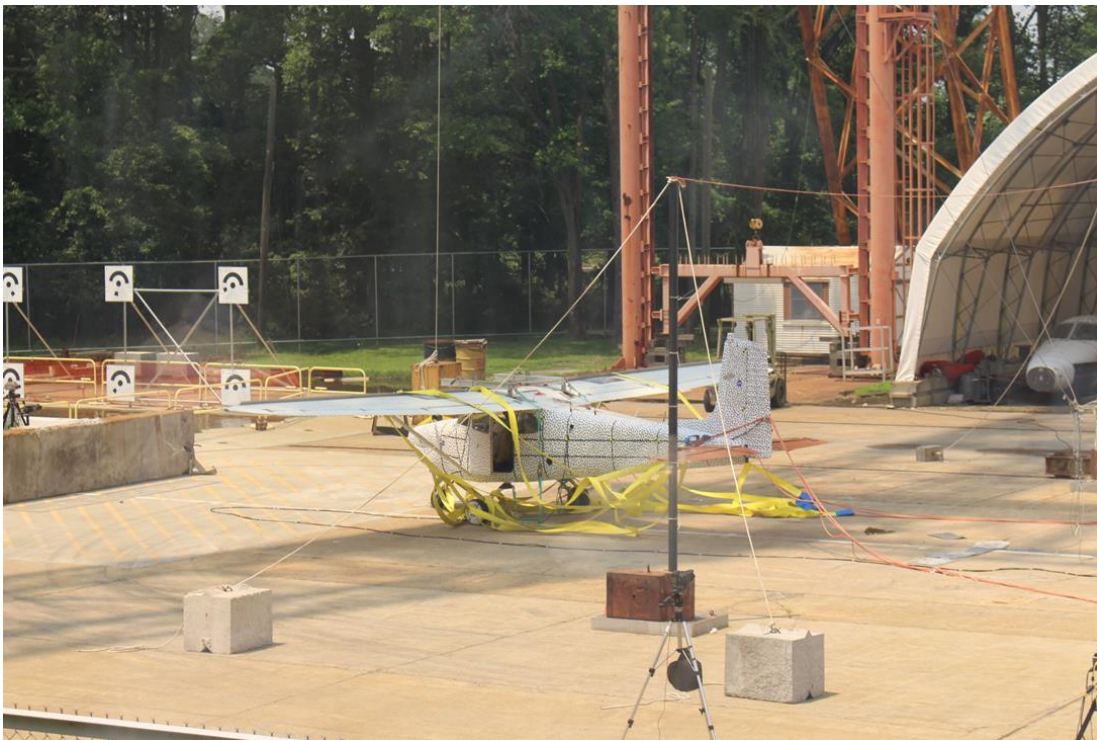
The airplane, stopped by the catch net, came to rest approximately 50 feet away from the initial impact location. The net was wrapped around the nose and wings of the airplane, stopping it within 20 feet of first contact. A photograph showing the post-test airplane and net is shown in Figure 12.

Figure 12 - Airplane configuration post-test

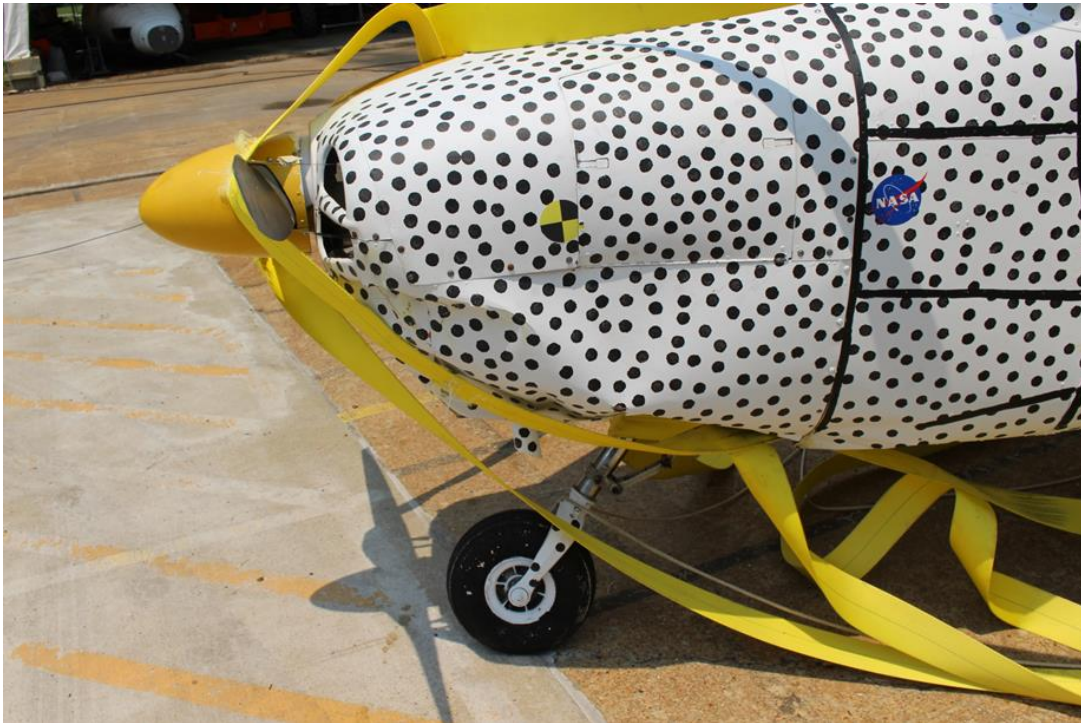
One of the first things that was noticed during post-test inspection was the unusual orientation of the nose gear. The gear, while still intact, exhibited an unusual forward lean angle, pointing much further forward than before the test. Inspection of the high speed videos suggests that the firewall attachment location of the gear buckled under the loads seen from the initial ground contact and the compression of the nose gear

during the time in which the main gear was deforming. This finding was confirmed when conducting post-test inspections of the firewall with the nose cover skin removed. The buckling of the firewall also caused dents to appear in the nose cover skin, as seen in Figure 13.

Figure 13 - Test 1 – Post-test nose buckling and landing gear orientation

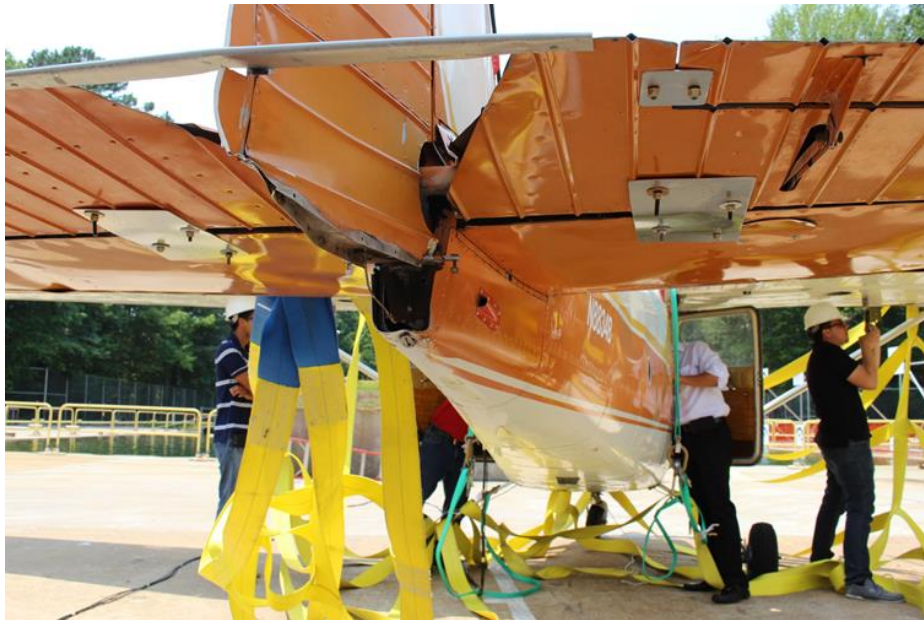
When examining the underside of the aircraft, the post-test inspections showed no damage on aircraft belly skin. A small portion of the vertical stabilizer broke away from the airplane during the second tail contact, which occurred during the net catch, as shown in Figure 15. Inspections of the internal structure of the tail showed small signs of buckling, mainly in the long unsupported spans where only the thin aircraft skin was present.

Figure 15 - Test 1 – Post-test tail damage

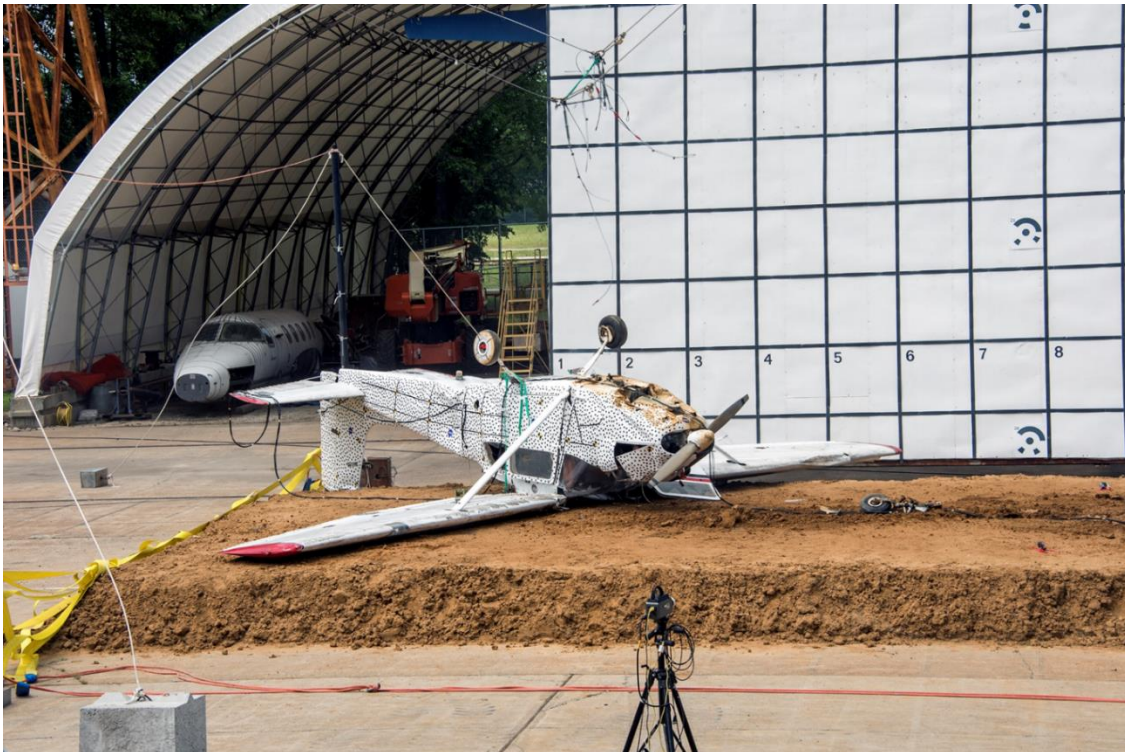
The airplane came to rest on the soil surface approximately 20 feet away from the impact point, upside-down and skewed toward the co-pilot's direction. The short slide-out distance is due to the flipping of the airplane at impact. The aircraft and separated nose gear can be seen in Figure 21.

Figure 21 - Airplane configuration post-test

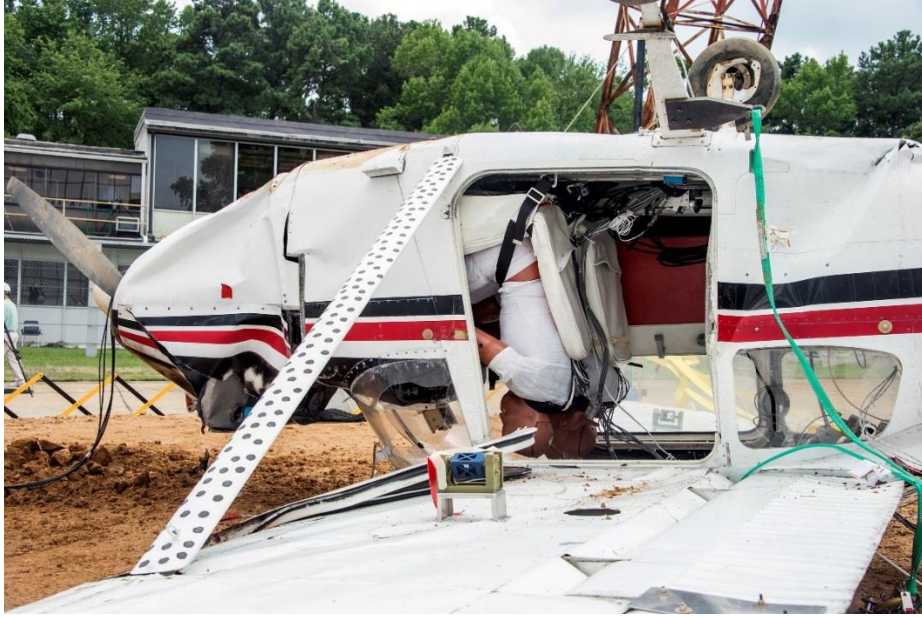
Figure 23 shows the extent of the damage on the co-pilot side of the airframe. A large gap, along with a large amount of skin buckling can be seen at the firewall location by the nose, and along the lower portion of the nose, near where the nose gear would normally be. Cabin damage is most noticeable by noting the co-pilot door has broken free from the rest of the airframe. The removed door, along with the creases in the skin behind the door, indicate large amounts of bending in the cabin area of the fuselage also.

Figure 23 – Test 2 – Post-test airframe damage - Nose and co-pilot side cabin

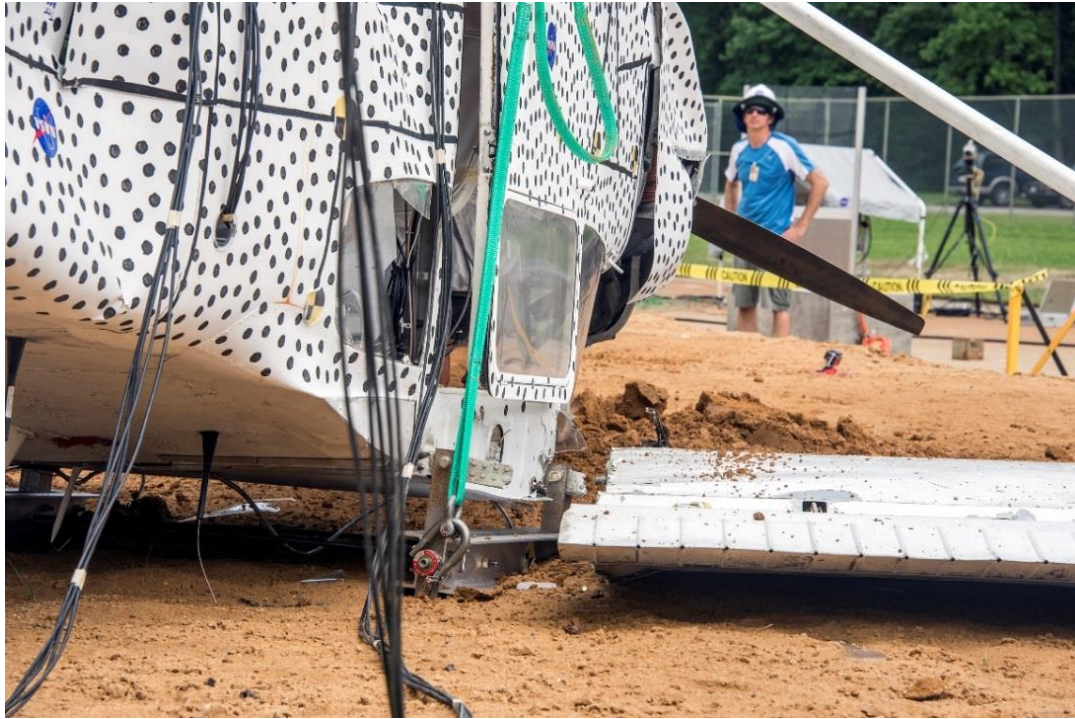
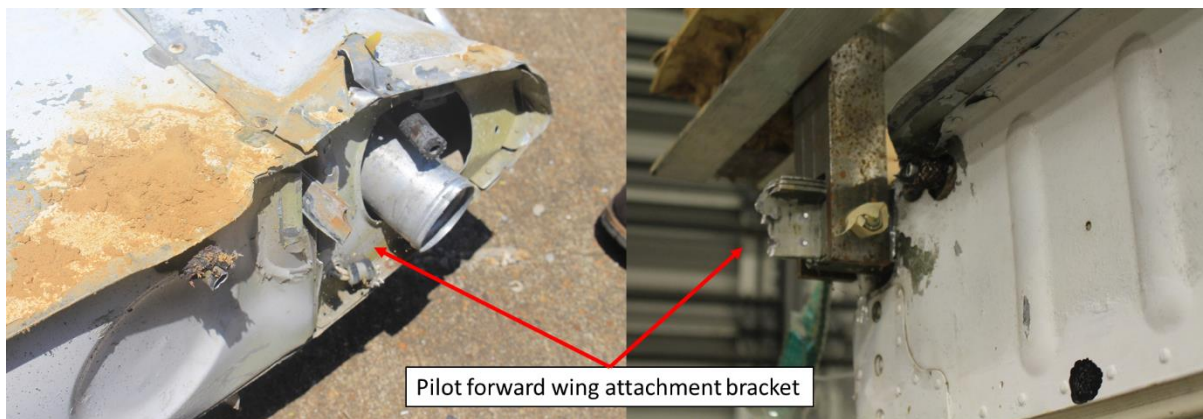
Damage on the pilot side of the airframe is most notable by examining the wing attachment locations, as shown in Figure 24. The attachment brackets on the wing connections fractured, causing the wing to come completely dislodged at the wing attachment locations on the fuselage and come to rest next to the body of the airplane. Further inspections of the wing attachment locations post-test suggest that age and wear on the wing attachment brackets caused this failure.

Figure 24 – Airframe damage - Pilot's wing. At impact location (top) and further inspections in the hangar (bottom)

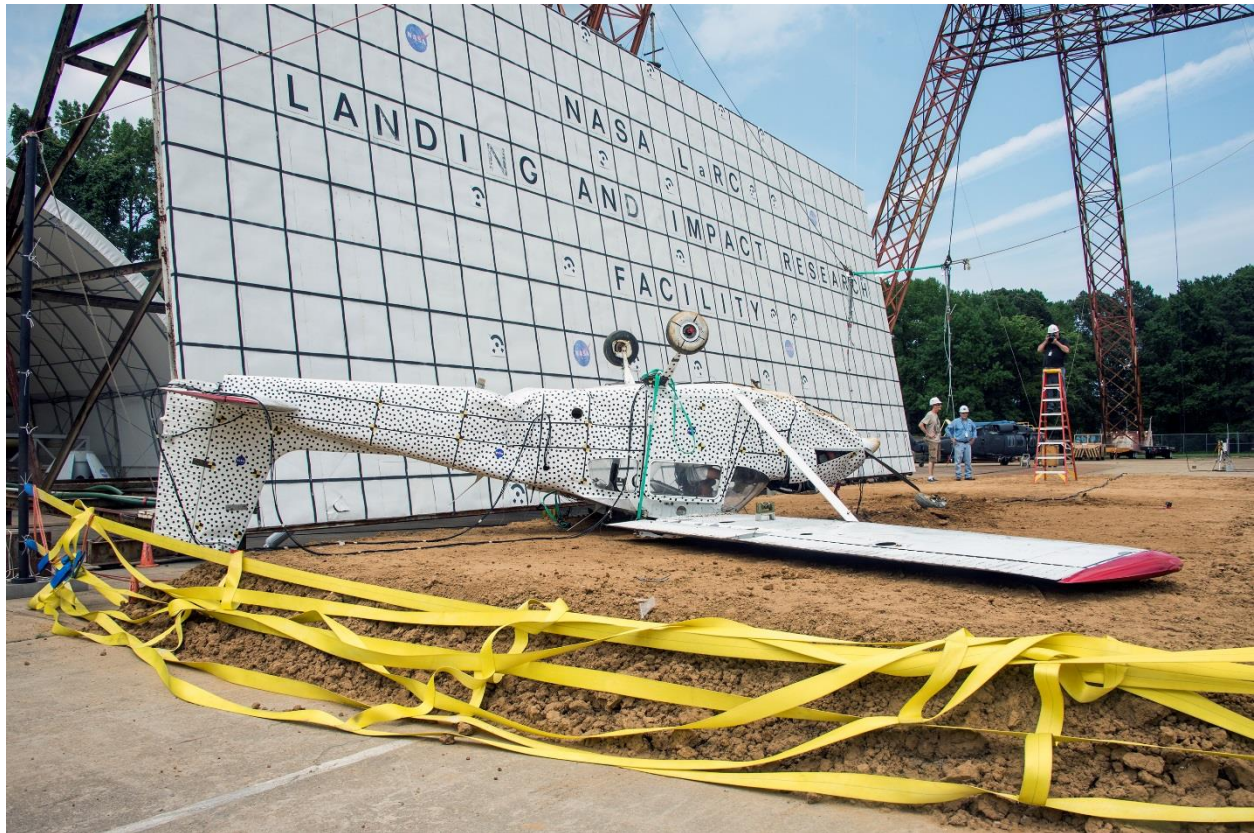
The tail also saw a large amount of deformation during the test, however it did not break free of the cabin. Instead, large amounts of buckling were examined in the area slightly aft of station 108, as shown in Figure 25. It is at this location where the floor of the cabin ends, and thus presents an area of differing overall airframe stiffness. It is likely because of the difference in stiffness that the buckling occurred in this region.

Figure 25 – Test 2 – Post-test pilot side tail damage

In both of the tests conducted onto soil, the tail buckled just aft of the cabin-tail junction. Even with the differences in tail design (straight tail for Test 2 and swept tail for Test 3), the difference in global stiffness between the cabin and tail resulted in an ideal spot for the initiation and propagation of buckling. The difference, however is the straight tail only showed signs of major buckling whereas the swept tail did exhibit fracture. The addition of the rear window in the swept tail design likely weakened the tail structure enough to cause the fracture, along with the differences in impact conditions, made for a larger vertical acceleration in the tail for Test 3.

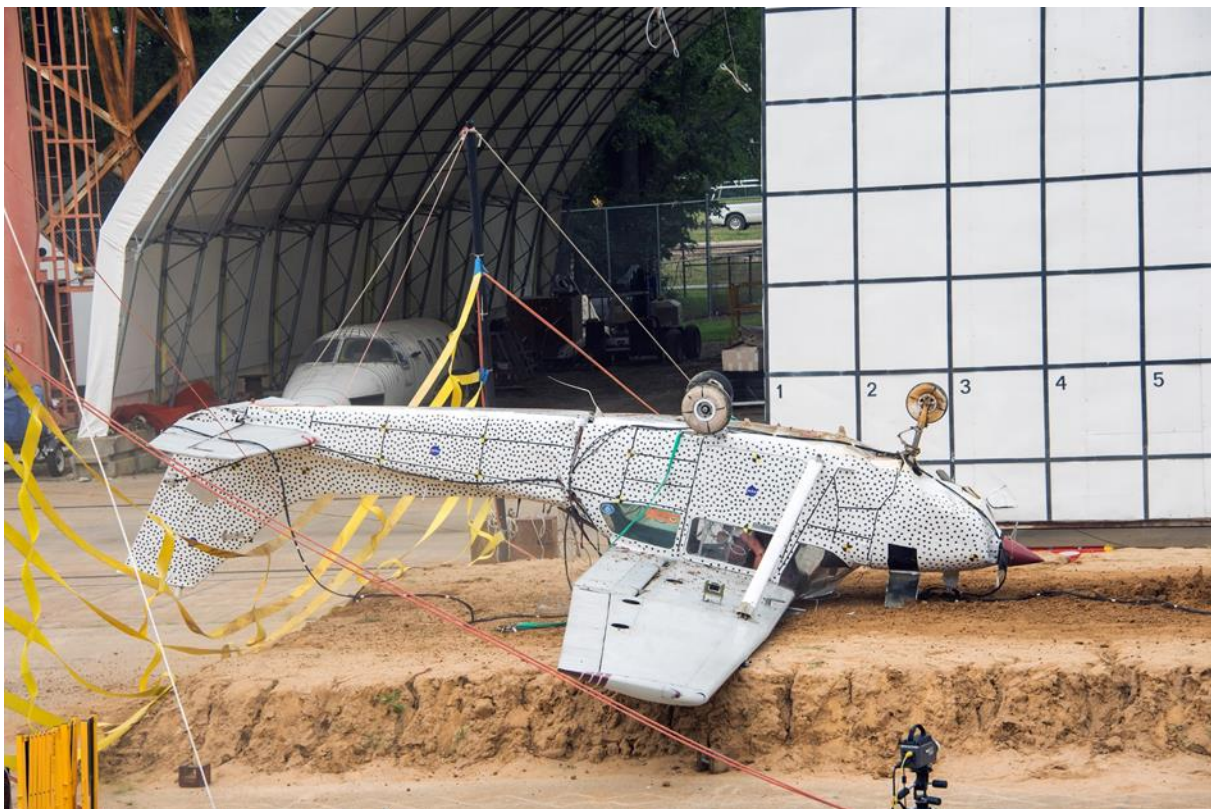
The airplane came to rest on the soil surface approximately 20 feet away from the impact point, upside-down and slightly skewed toward the co-pilot's direction (right side). The short slide-out distance is due to the flipping of the airplane at impact, as shown in Figure 32.

Figure 32 - Airplane configuration post-test

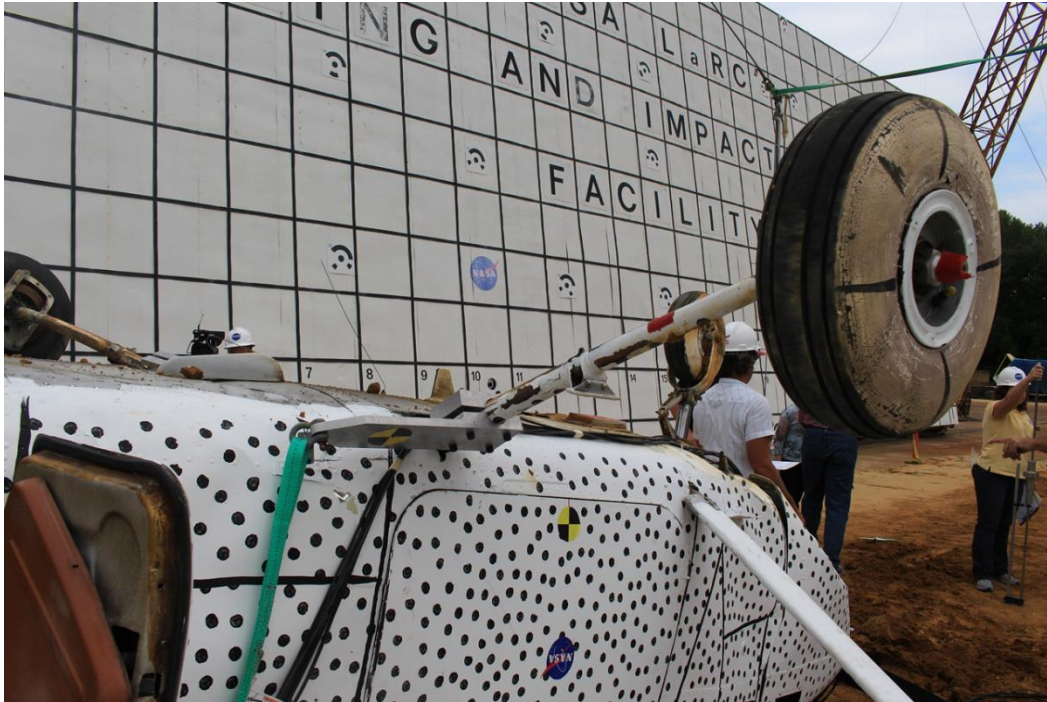
Unlike Tests 1 and 2, the landing gear on Test 3 consisted of a hollow tube design. Normally covered by fairings (removed for the crash tests), the tubular landing gear exhibited large amounts of plastic deformation post-test; however, the tubes did not break. The impact with the soil surface due to the slap-down caused these permanent deformations to occur. The wheels appeared to be intact post-test, as shown in Figure 34.

Figure 34 – Test 3 – Post-test landing gear deformation

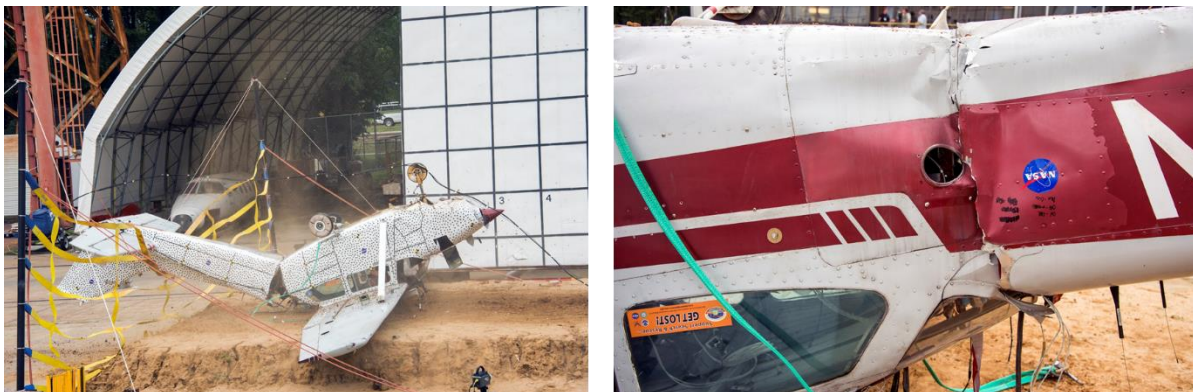
The tail fracture occurred just aft of the 108 station in the airplane, where the cabin transitioned into the tail. This transition area offered an ideal place for failure due to the differences in stiffness. A still image is captured during the test in Figure 35, left, showing the opening caused by the fracture in the tail during the test. Figure 35, right, shows a close up of the fracture, which is located just aft of the rear window, at station 108.

Figure 35 – Test 3 – Post-test tail failure
